Saint Mary's Cemetery

Lot Report

Lydia Hamilton Smith Plot

Section 2, Row 6, Gravestones 17 & 18

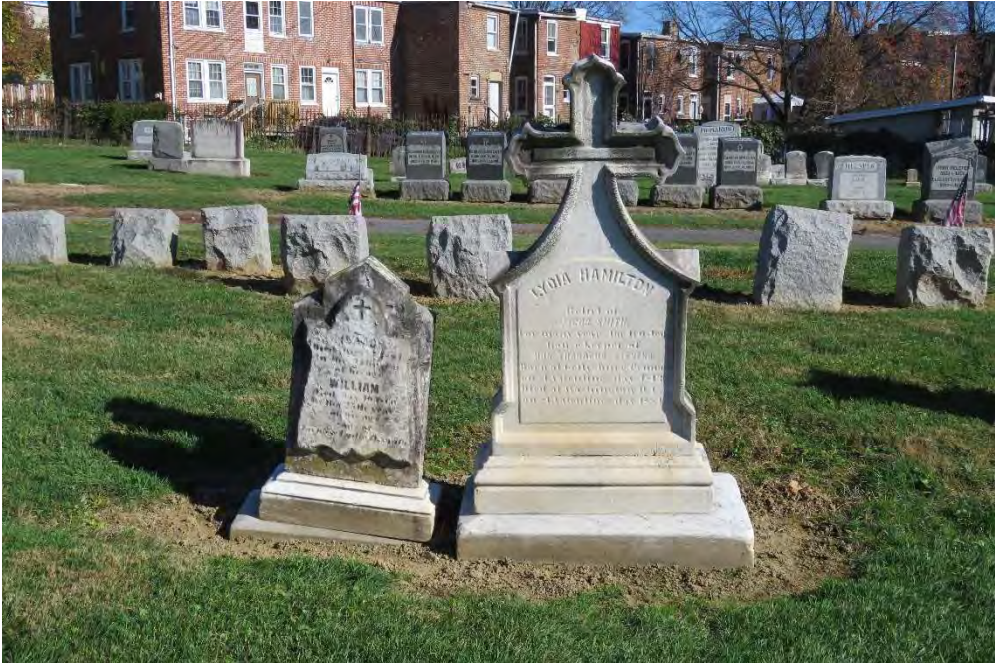
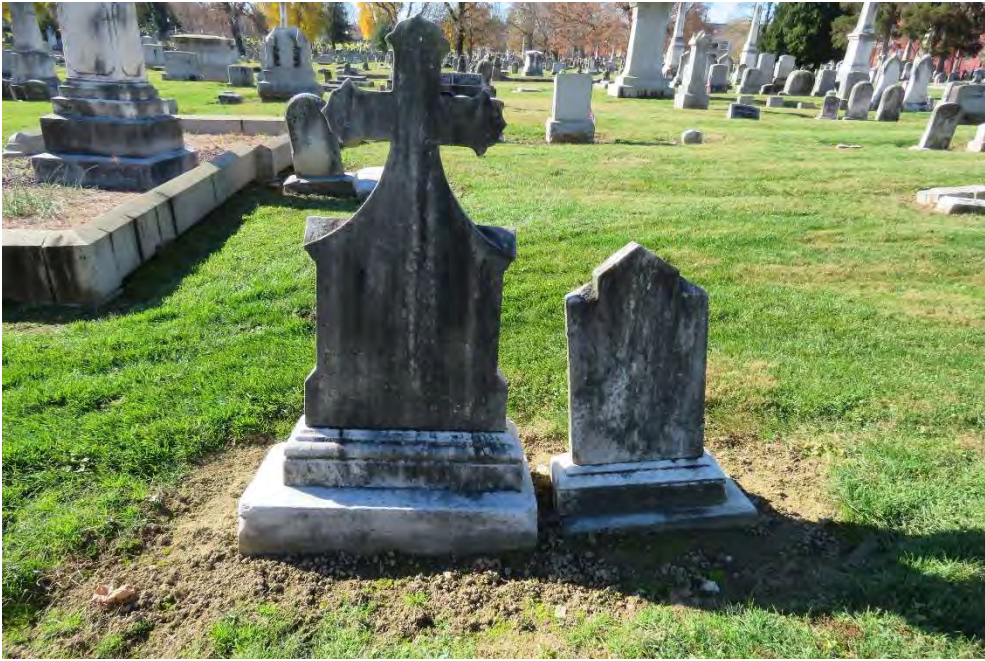
This plot consists of two gravestones each attached to a separate tier, resting on individual bases aligned in a straight line. Both stones are leaning and tilting, as can be seen in the photos below. The tiers have slid a few inches off their bases which have sunk several inches into the ground. Both stones are dirty and weathered. The condition of the Isaac and William Smith stone is poor, rendering the engraving almost unreadable. The Lydia Hamilton Smith stone is very readable.

Front

Back

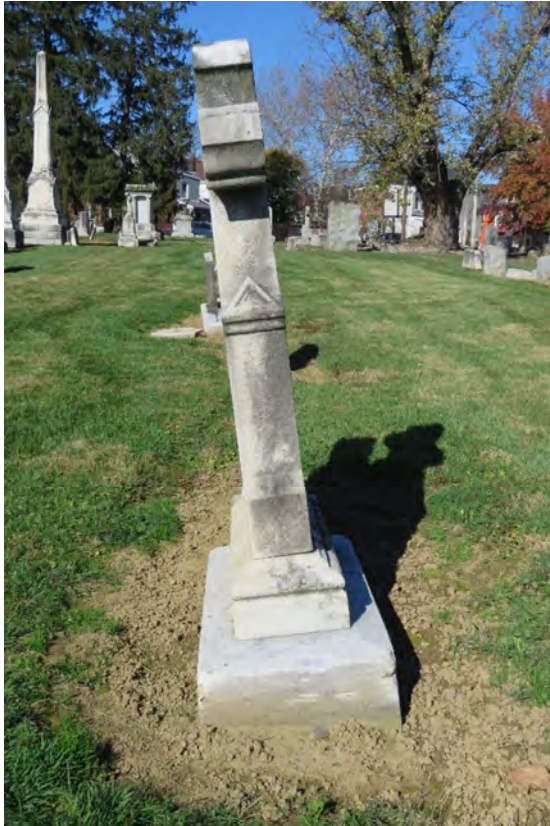
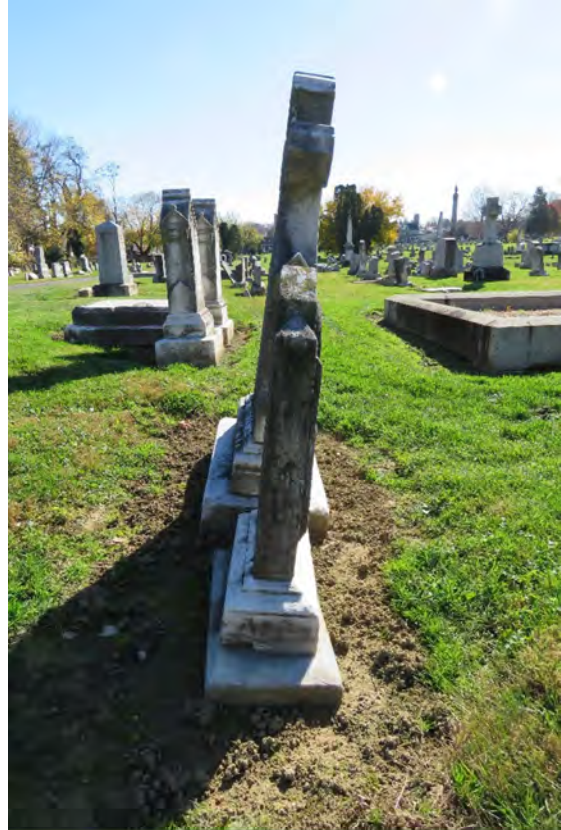
Right Side

Left Side

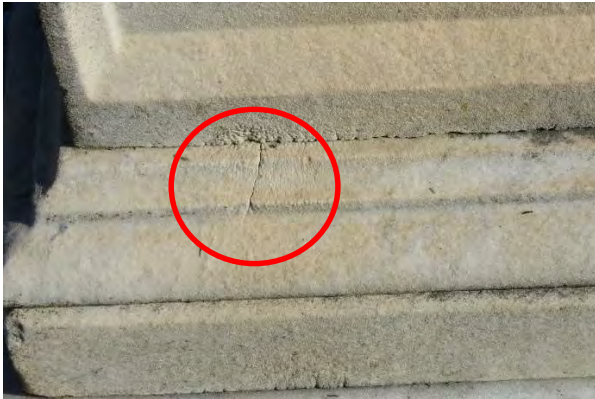
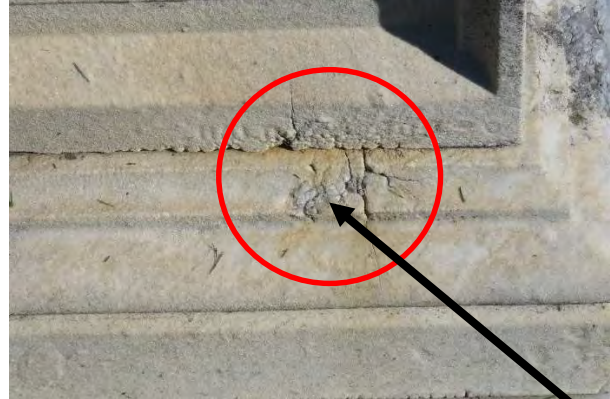
The Lydia Hamilton Smith stone is tilting front at an unsafe angle (12°). The die is also loose in the tier. It can be moved slightly back and forth with mild force. Cracking exists in the tier at both pin locations. (See photos below.)

Stone #1 Front: Cracking at Pin Locations and quartz Inclusion

Quartz
Inclusion

Since the die and tier did not separate enough during the move to insert a saw blade to cut the pins, it was decided not to attempt to separate them and replace the pins. Separating the die further from the tier would most likely have caused some damage to the stone. The die will be stabilized using mortar after the die/tier unit is set back on the base.

The die/tier unit was trolleyed and placed on the base. Four thin plastic shims were placed on the corners of the flat portions of the base and the die/tier unit was then lowered on to the base. To stabilize the die on the tier and to limit further degradation of the setting pins and the sulfur they were set in, the gap between the die and tier was filled with a mix of Lithomex Antique Marble tinted with gray. Excess Lithomex was removed and after drying sufficiently any remaining Lithomex was removed with a wet sponge. The same procedure was performed where the die/tier unit mated to the base.

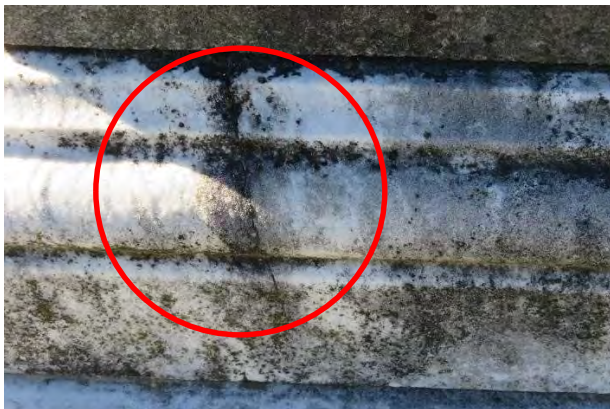
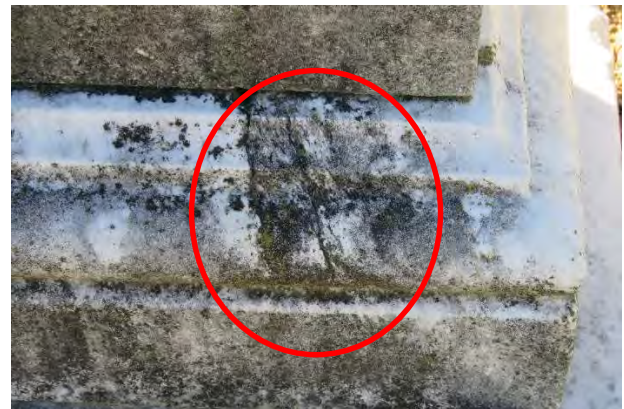
Stone #1 Rear: Cracking at Pin Locations

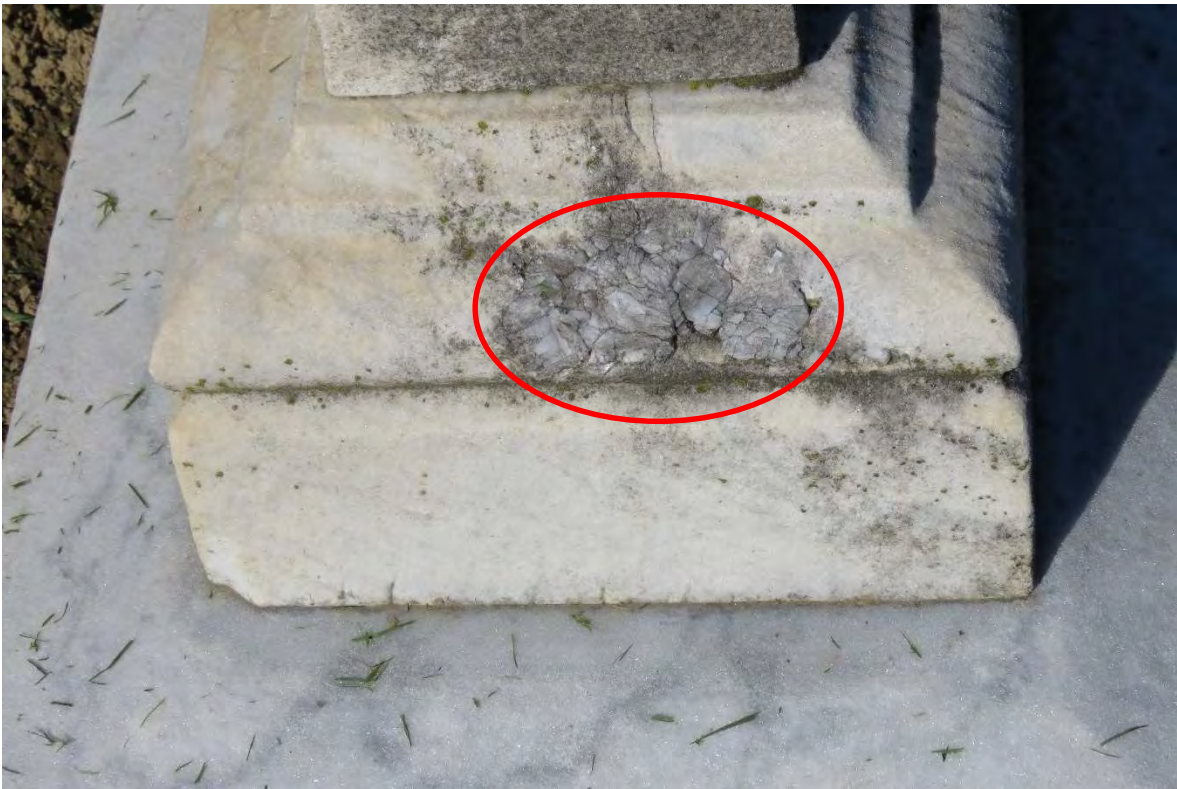
Stone #1: Tier – Right Side Quartz Inclusion Area

Tier: It has slid off base 1½". Cracking found at all pin locations. Right side has a quartz inclusion (4"x2"), chip missing from right front corner (~½"). There is a quartz inclusion on the front right side.

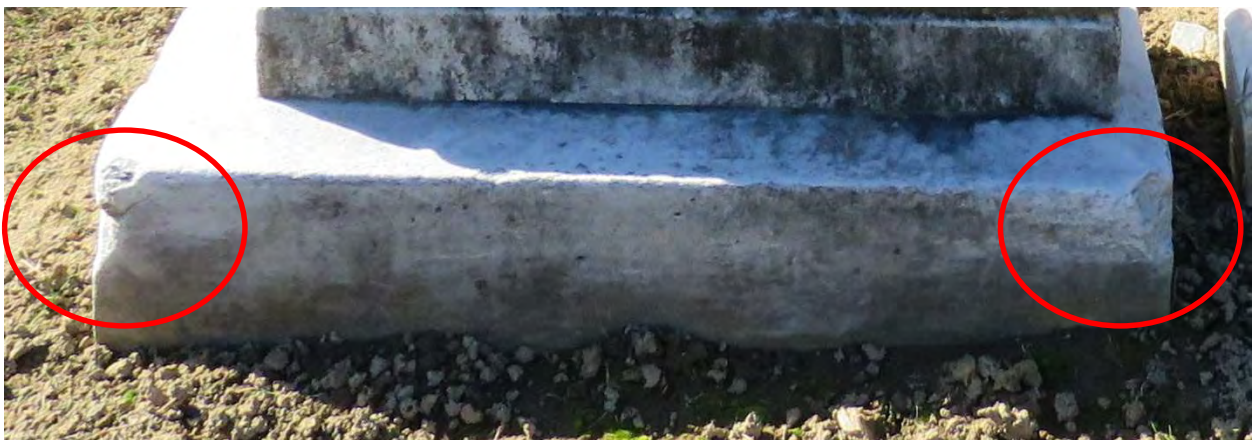
Also, chips are missing from the base at each corner. The most significant are at the rear of the base. (See photo below)

Stone #1 Base Rear: Corner Chips Missing

Base: It has sunk 3". Chips missing from each corner, largest is left rear (3"x2"). Minor ware on right face.

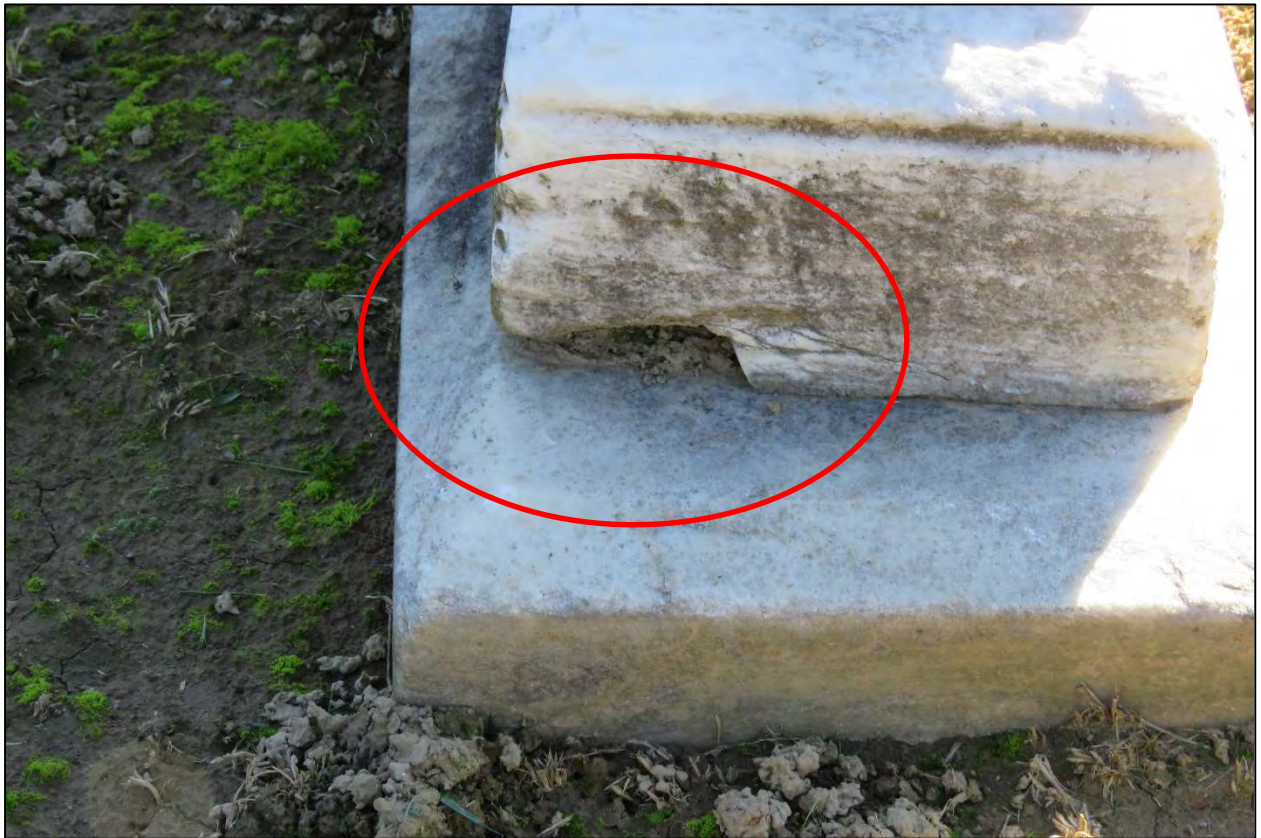
This stone is tilting front but not as severely as Lydia's stone. The die is loose in the tier. It can be moved slightly back and forth with mild force. There is no evidence of cracking at the pin locations. There is a significant piece missing from the left rear corner of the tier. See photo below. In addition, there is noticeable flaking on the rear of the die.

Stone #2: Tier – Left Side missing chip

Tier: Has slid off base 2"; Left side bottom corner – chip (3"x2"x1") missing.

The die/tier unit was manually slid first on to wood shoring and then on to the base. To stabilize the die on the tier and to limit further degradation of the setting pins, the gap between the die and tier was filled with a mix of Lithomex Antique Marble tinted with gray. Excess Lithomex was removed and after drying sufficiently any remaining Lithomex was removed with a wet sponge. The same procedure was not performed where the die/tier unit mates to the base due to the large chip missing from the tier back left corner. A complete sealing of the joint between the tier and base was not possible due to the missing chip. The tier was a dry set on to the base at this time, so the large chip can be repaired at a later date. After the corner repair is completed, Lithomex can be applied to the tier/base joint.

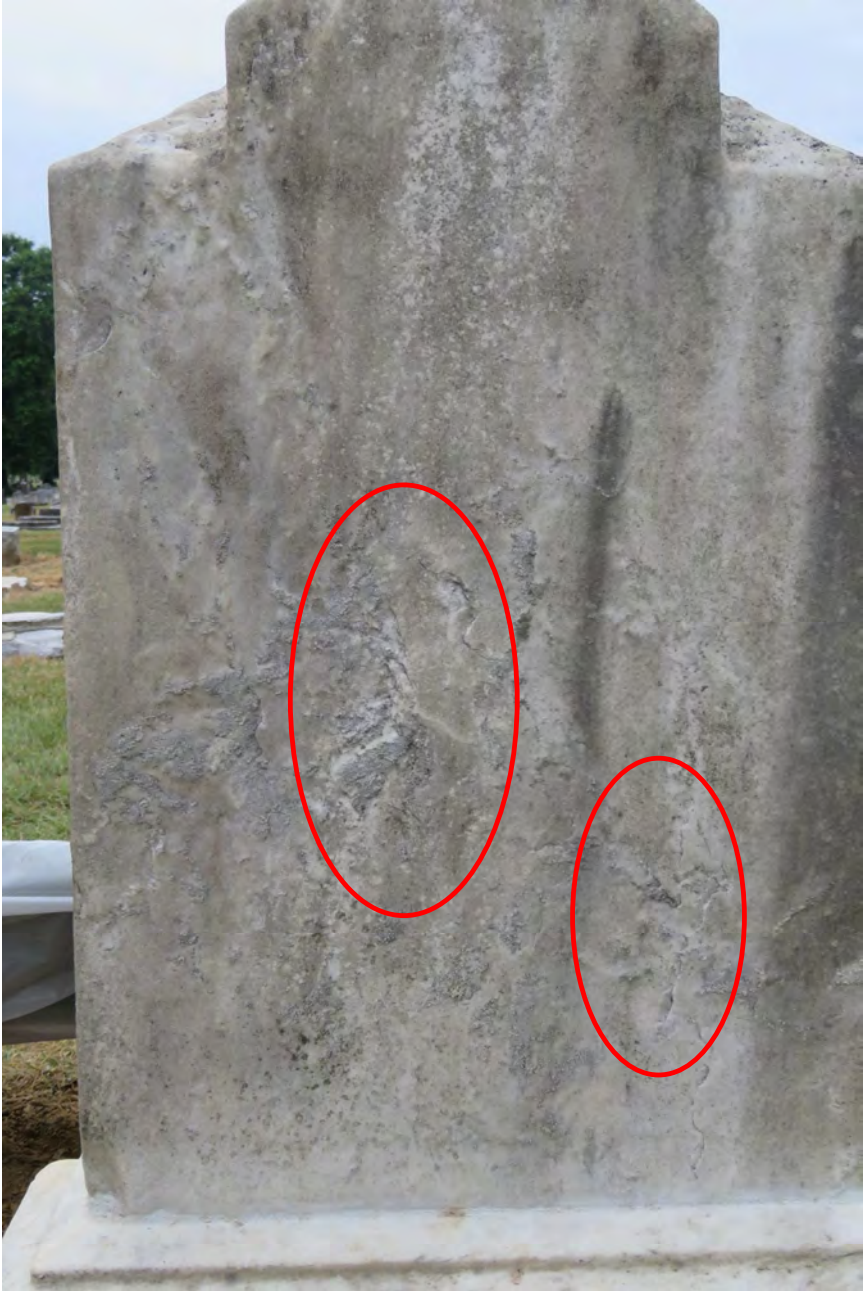
Stone #2: Flaking on Rear of Die

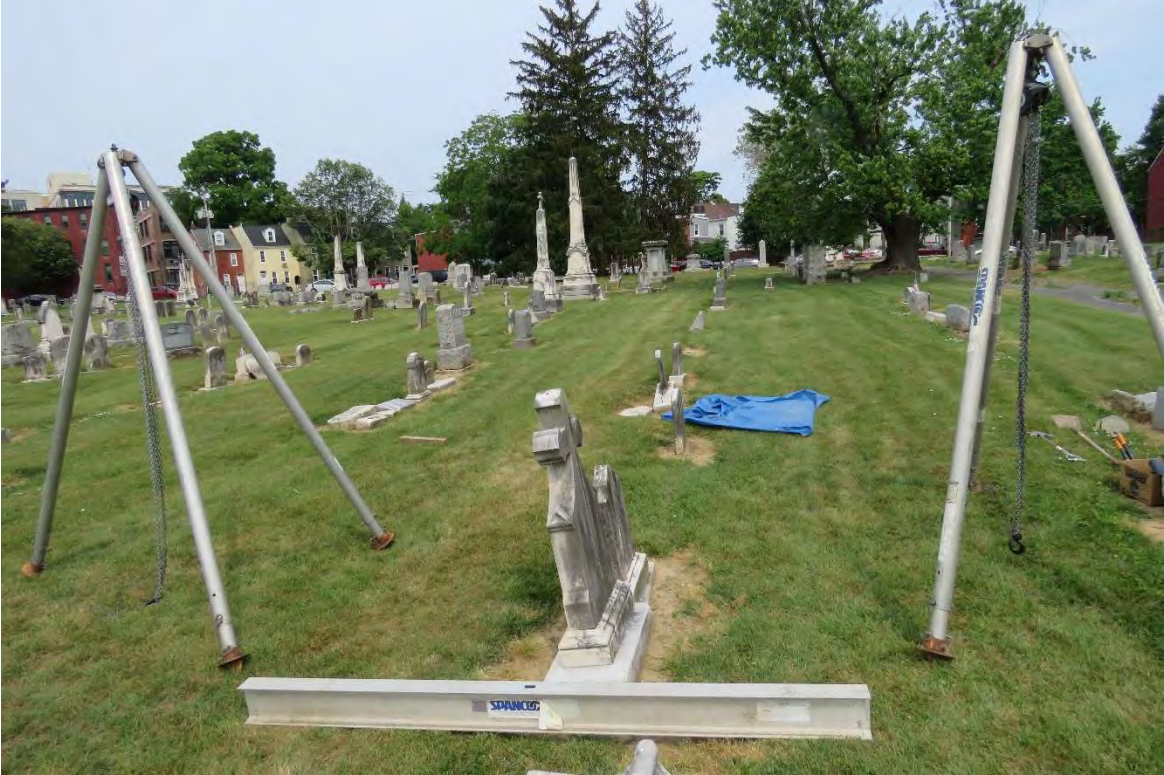
Aluminum Tripods & I-Beam

Stone #1 was draped with a folded tarp to protect it from being scraped while positioning the rigging equipment. A gantry on two telescopic aluminum tripods was assembled over the stone #1. See rigging assembly pictures below. A sling was attached to the stone and hooked to the main hoist. The stone was lifted and the die and tier raised off the base. Initially there was a slight gap between the rear of the die and the tier due to rust-jacking of the pins. No additional separations occurred during the lift. The die and tier were moved away from the base using the trolley and placed on shoring.

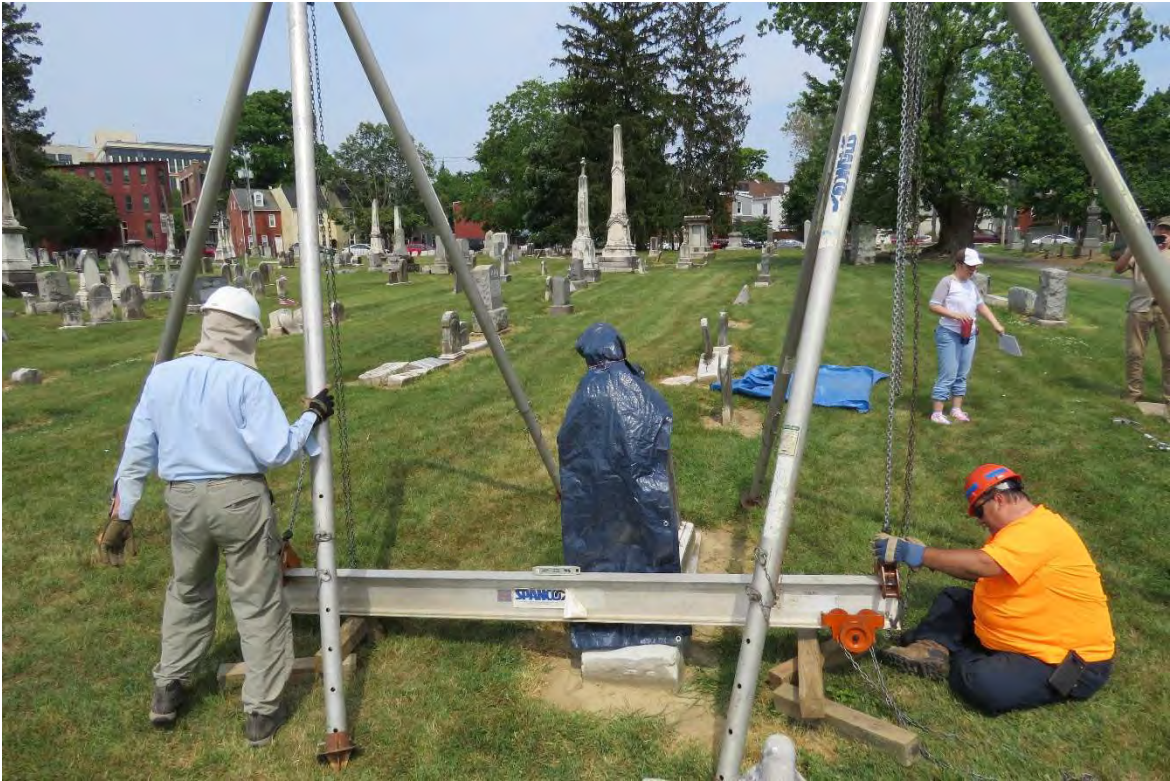
Trolley and One End Hoist attached to I-Beam with Level Attached to Center of I-Beam

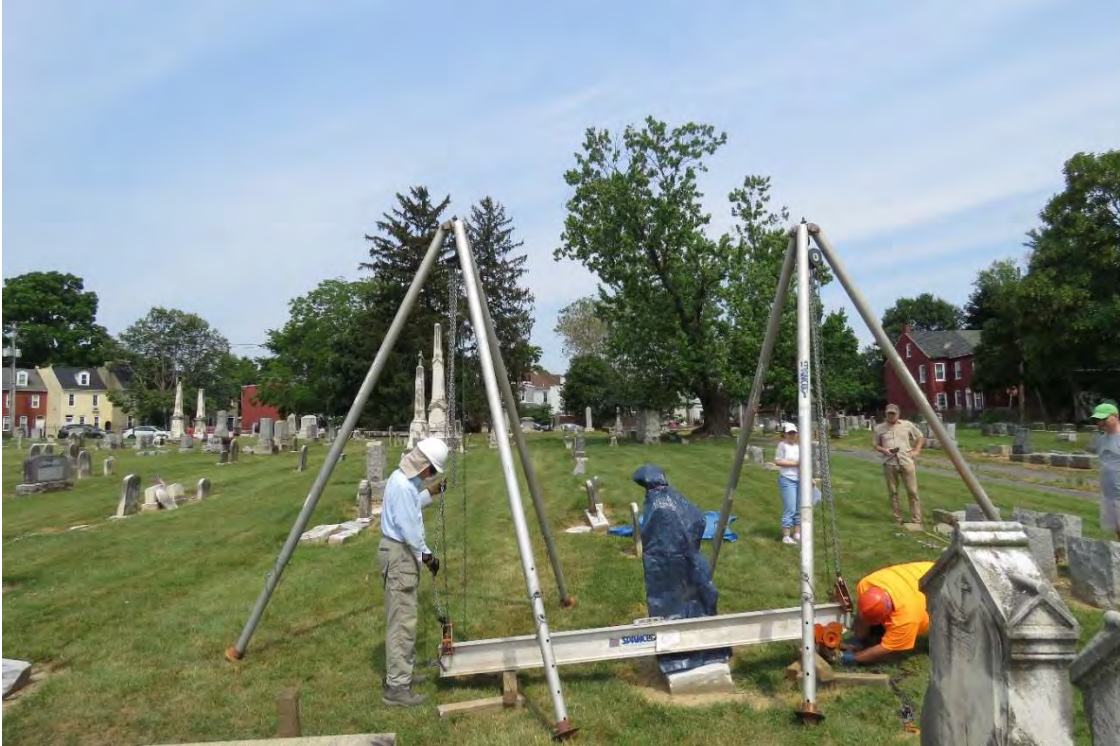
Two I-Beam Hoists Attached to I-Beam Ends with C-Clamp Stops & Main Hoist Attached to Trolley

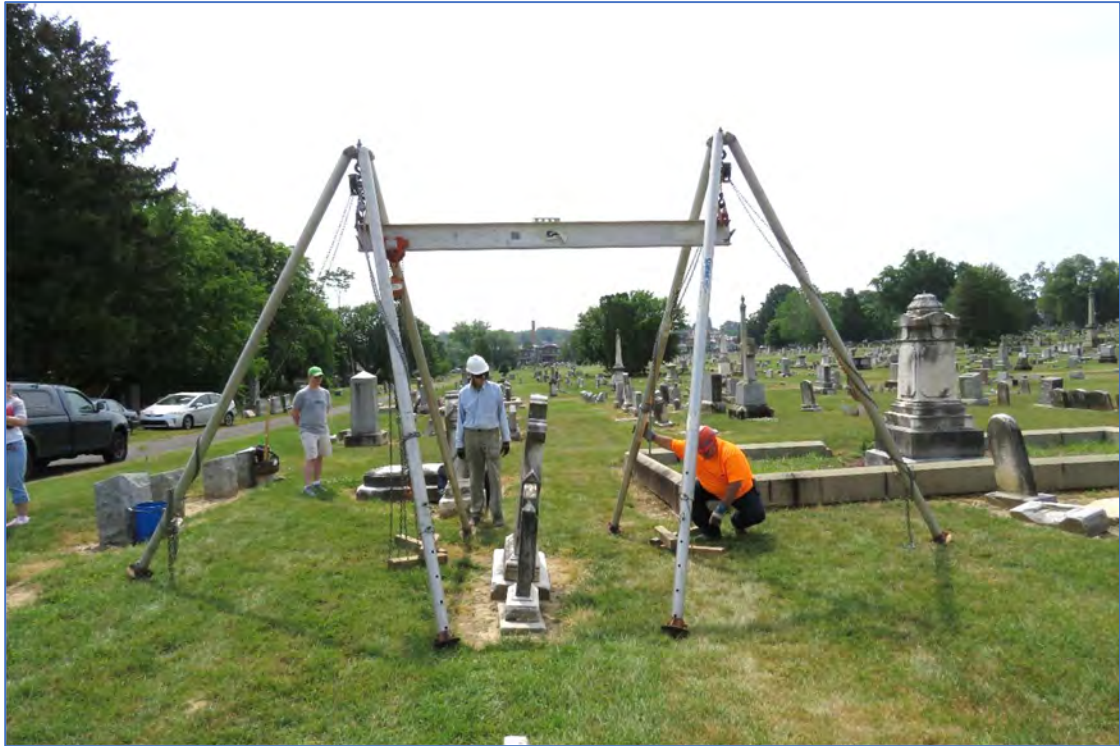
Gantry Completely Assembled

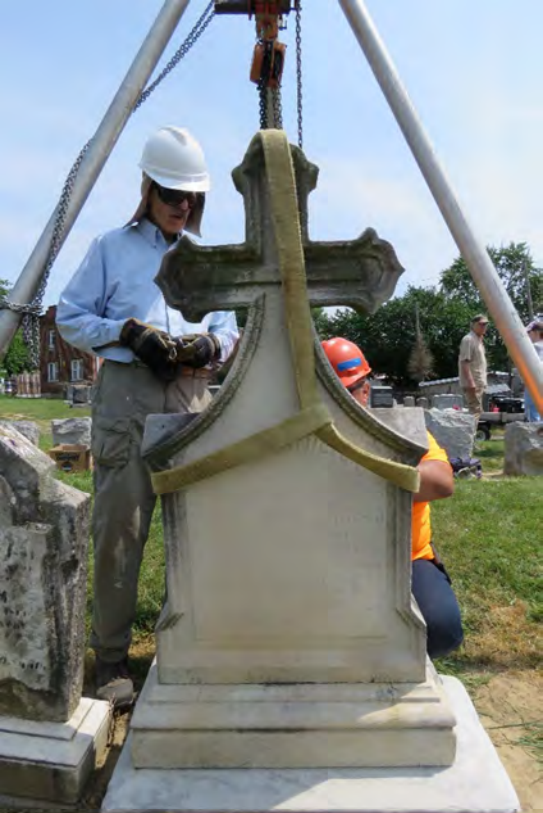
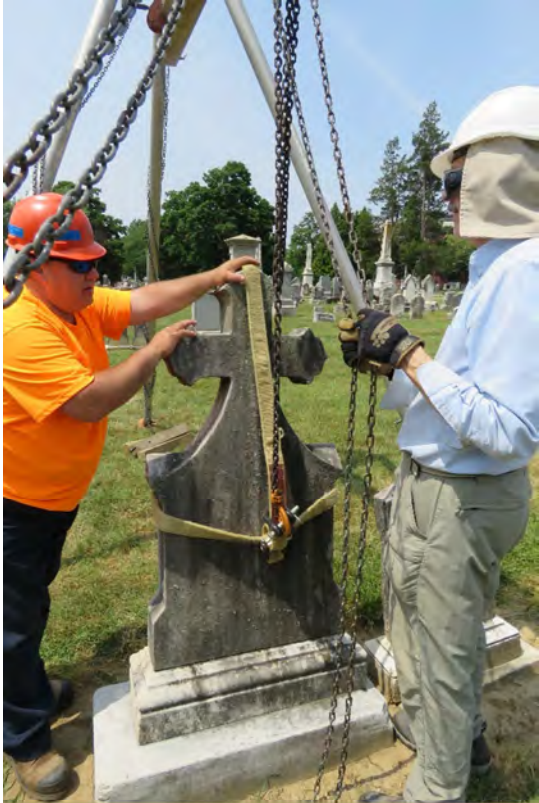
Stone #1 Die & Tier Rigging

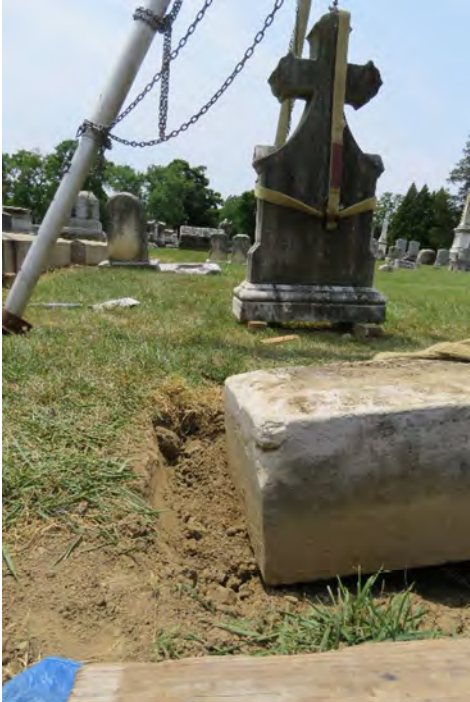
Stone #1 Die & Tier Removed and Placed on Shoring

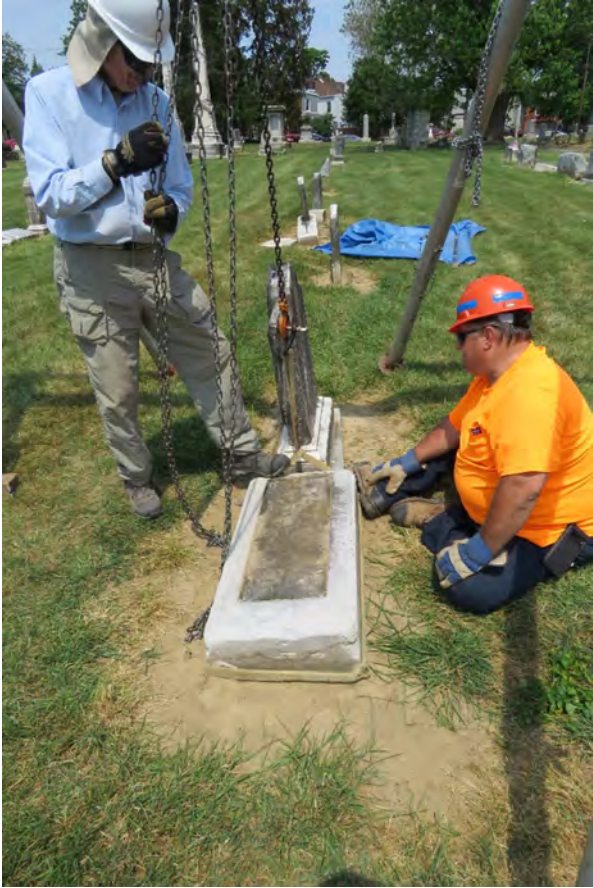
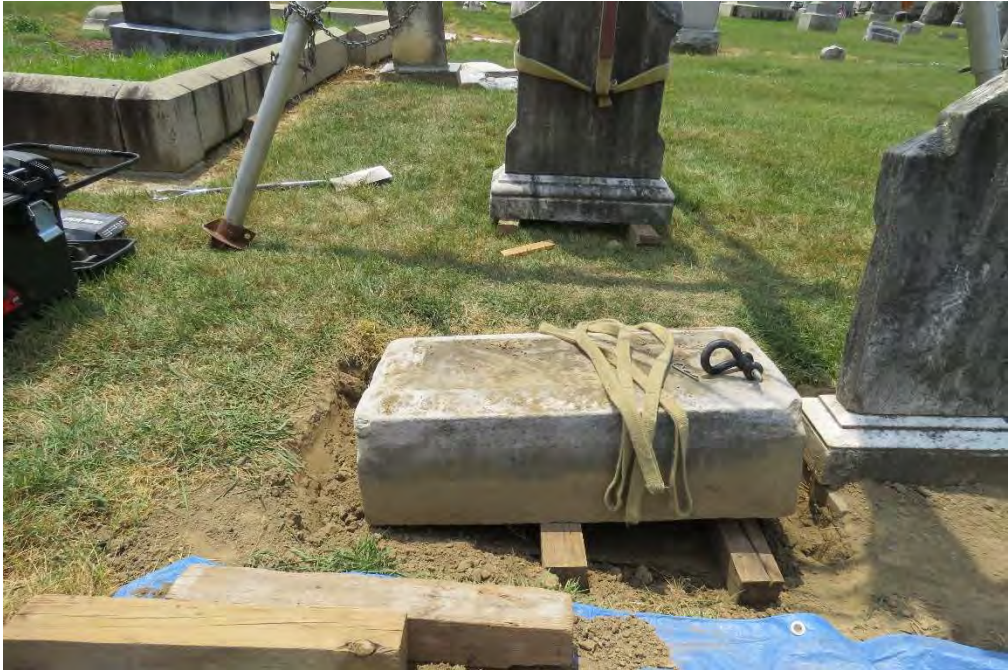
Stone # 1 Base Rigged and Lowered on to Shoring

The soil around the base was excavated to expose the bottom of the base. During the excavation a metal ground marker stating "ANNUAL CARE" was discovered in the ground at the back center of the base. The ground marker was removed. A sling was attached around the base and raised by the main hoist. Two pieces of shoring were placed under the base which was then lowered on them. The base was re-rigged, raised and trolleyed out of the way. During the excavation two red bricks were discovered at odd angles. These bricks had been displaced as the gravestone sank into the soil.

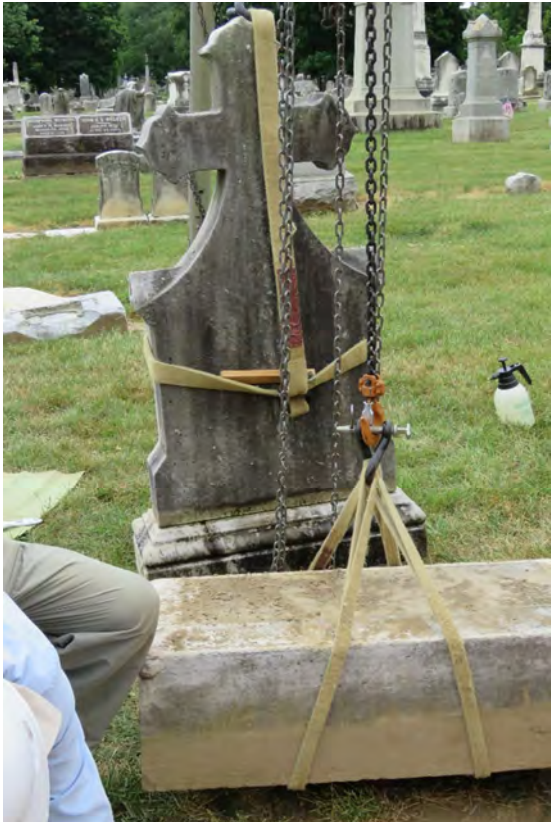
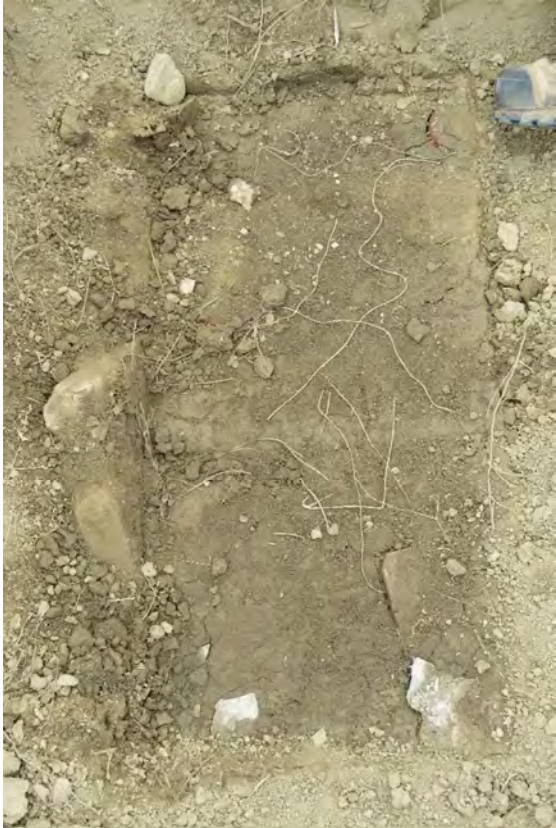
Stone #1 Base Raised and Base Foot Print Exposed

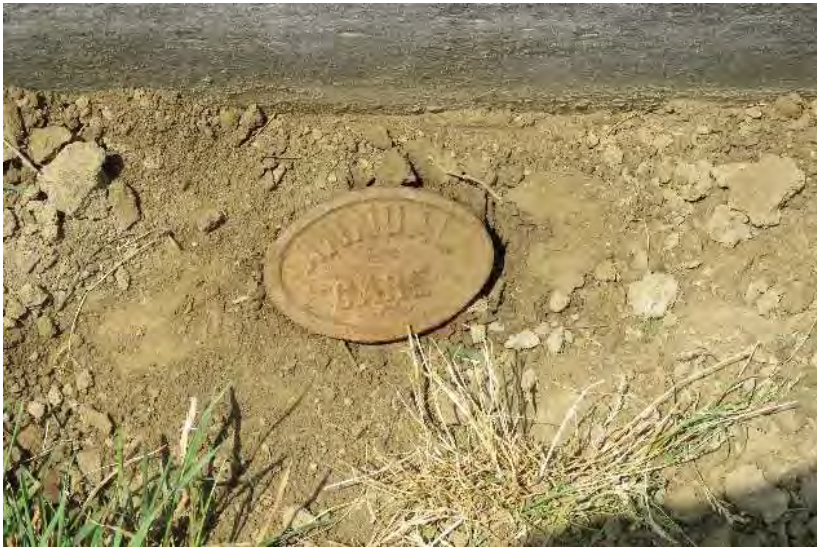
"ANNUAL CARE" Ground Marker Discovered

As mentioned, during the excavation of Lydia Hamilton Smith's gravestone base, a metal ground marker stating "ANNUAL CARE" was discovered in the ground at the back center of the base. The ground marker was cleaned with water and the rust removed with five applications of Rust-Oleum Rust Dissolver Jelly. The marker was then painted with Krylon Fusion Gloss Black spray paint. The marker was then placed in the ground at the back center of Lydia Hamilton Smith's gravestone base where it was found. Below are photos of this process.

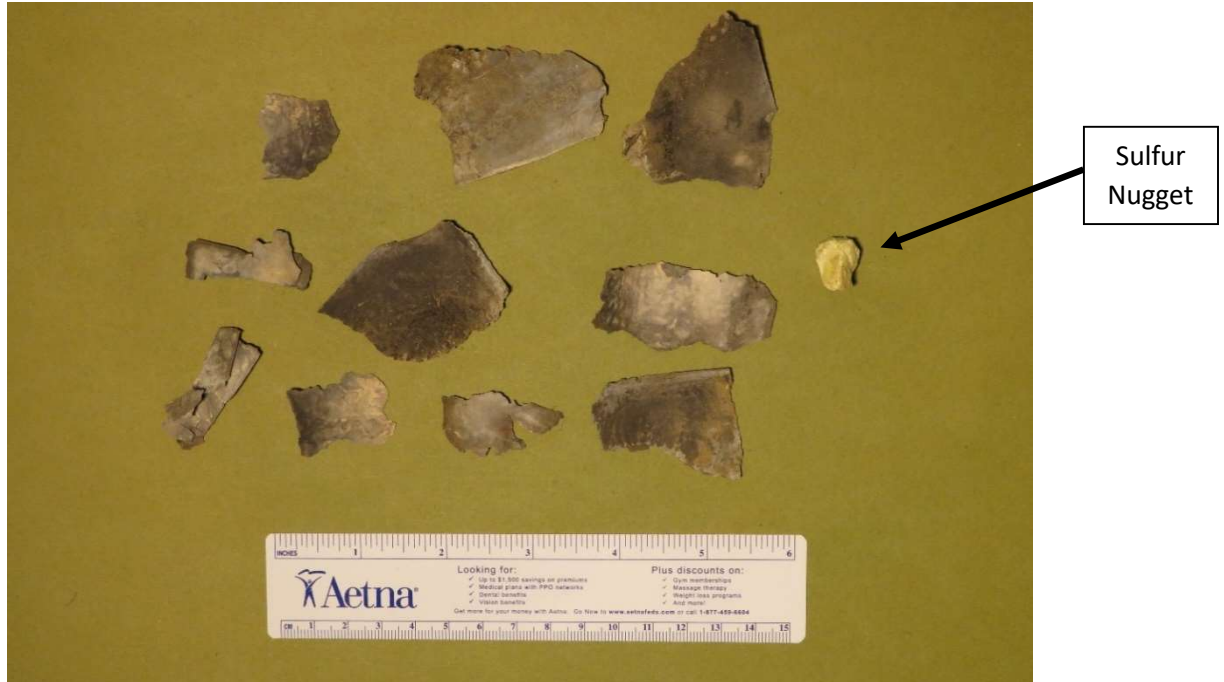
Removed Pieces of Pressed Lead and Sulfur Nugget

The space between the die and tier was flushed with water and a putty knife was slid between the surfaces. This procedure was repeated until only clear water came from the space. In addition to dirt, thin metal strips of pressed lead were removed as well as specks of yellow sulfur, including a small ½ inch diameter nugget from a pin pour spout. The bottom of the tier was cleaned with water and a bristle brush.

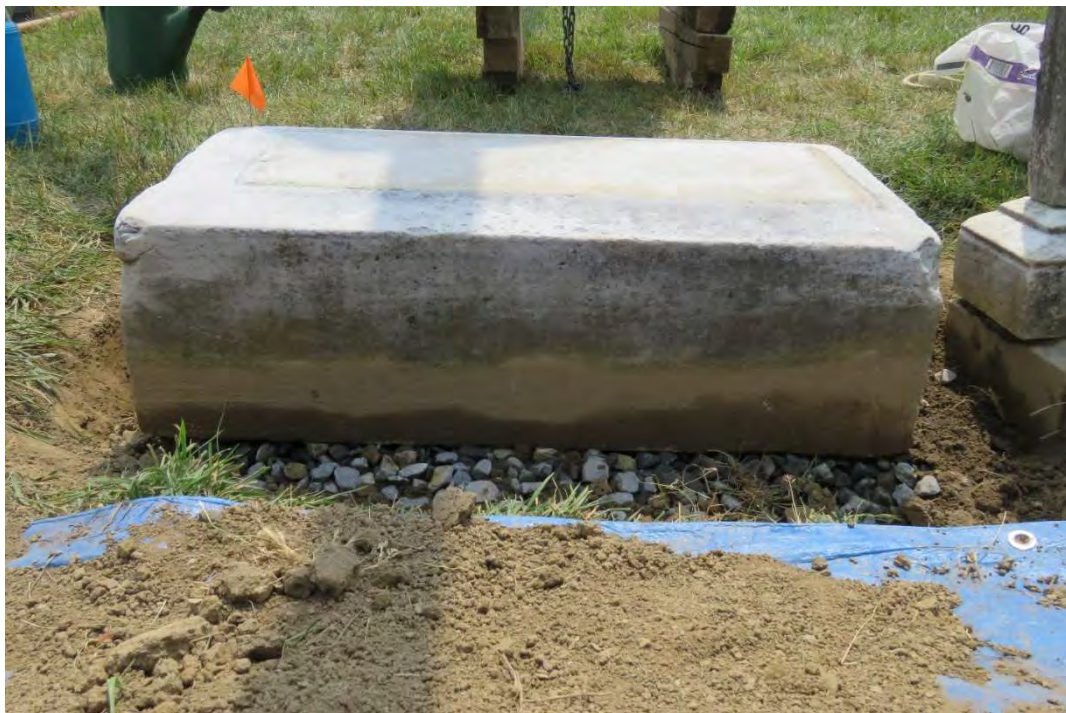
Stone #1 Base on a Bed of Drainage Rock

The space under the base was excavated further, and two and a half 0.5 Cu. Ft. bags of drainage rock were placed in the hole. The base was then trolleyed back to its original position and leveled. The top of the base was cleaned with water and a bristle brush.

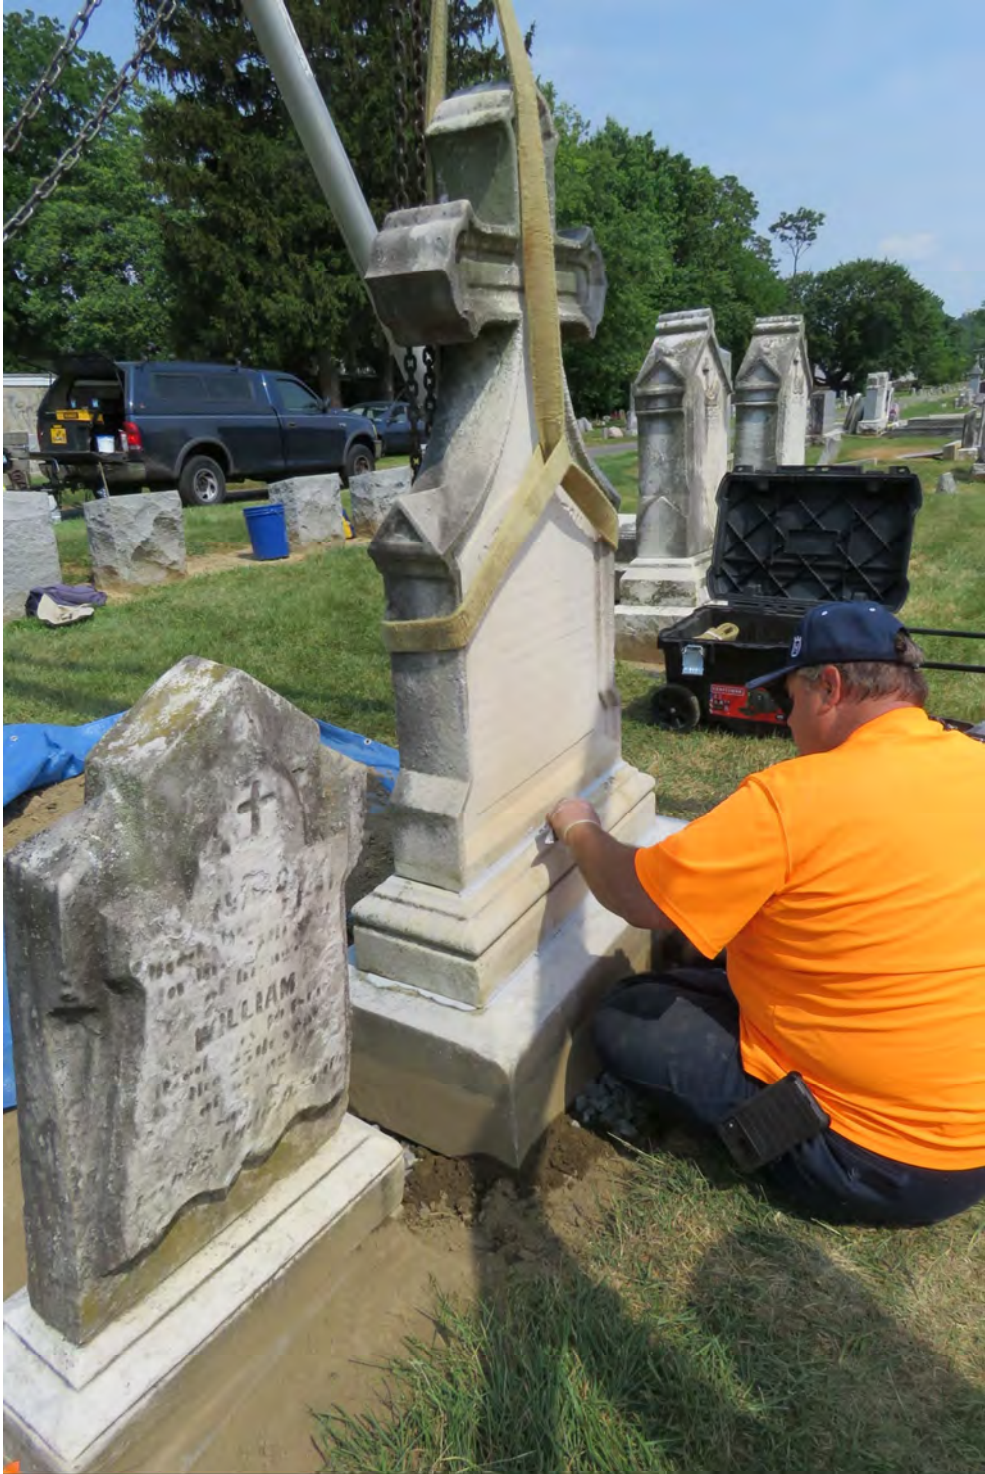
Robert Mosko Smoothing Mortar at Die/Tier Joint

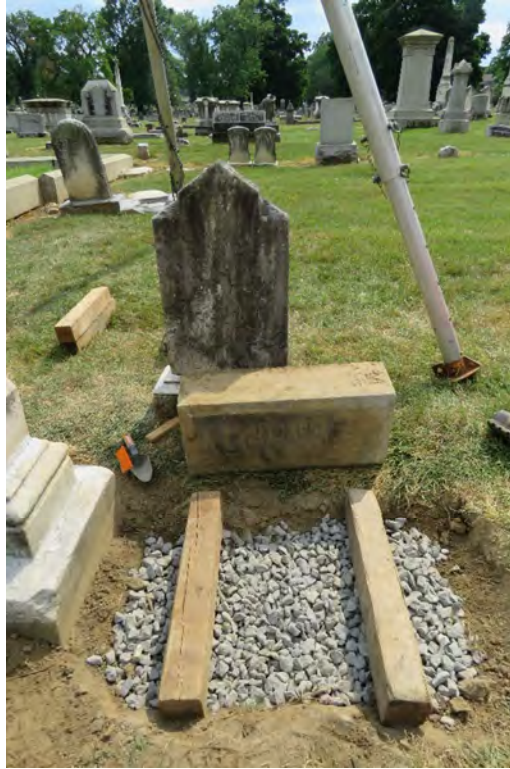
Stone #2 Die & Tier Unit and Base Moved with New Foundation Bed

The Stone #2 die and tier unit was significantly lighter than Stone #1. It was manually slid off the base and first placed on its side on two pieces of shoring. To facilitate cleaning the gap between the die and tier, it was lifted to the upright position.

Two 0.5 Cu. Ft. bags of drainage rock were placed in the hole. The base was then manually positioned on to two pieces of shoring. The base was manually slid on to the drainage rock bed and positioned so that its left edge was 68" from the right edge of Stone #1 base to accommodate the sign, then leveled. The top of the base was cleaned with water and a bristle brush.

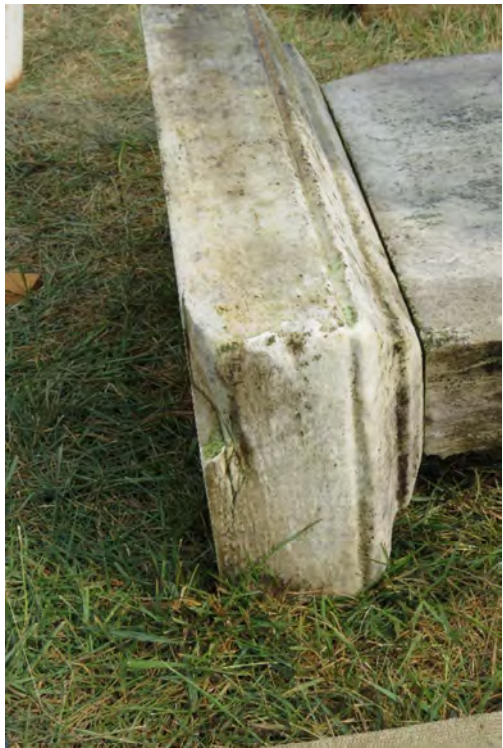
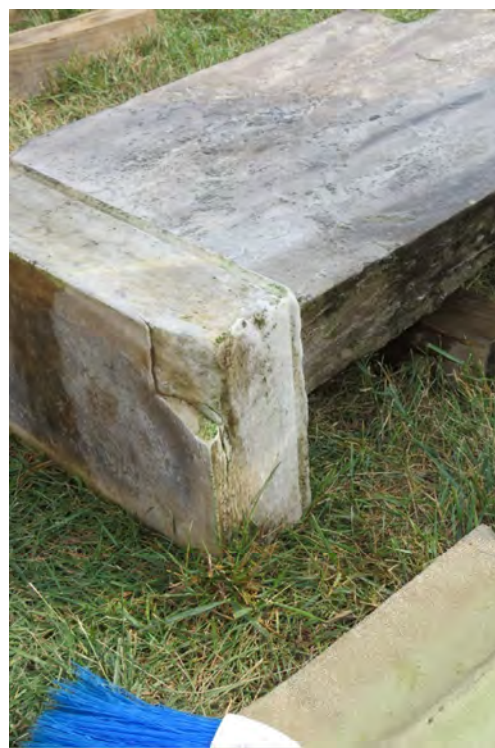
Closeup Views of Tier Corner Damage

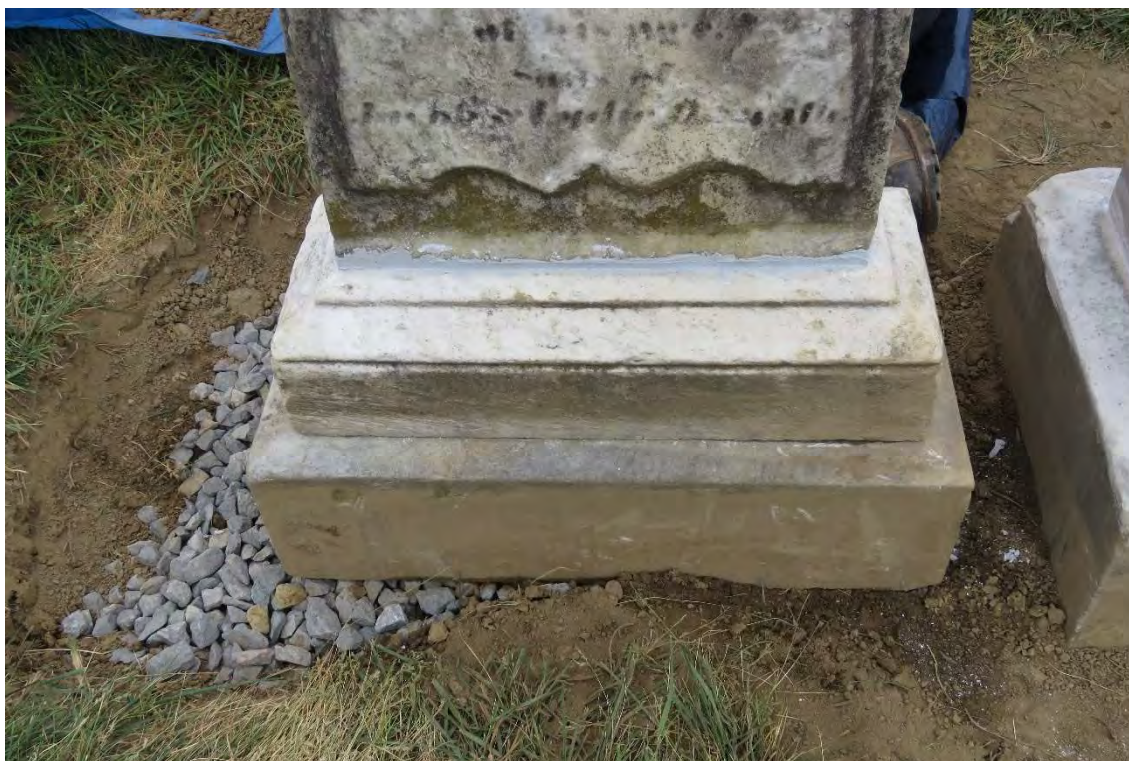
Stone #2 Reset on Bed of Drainage Rock

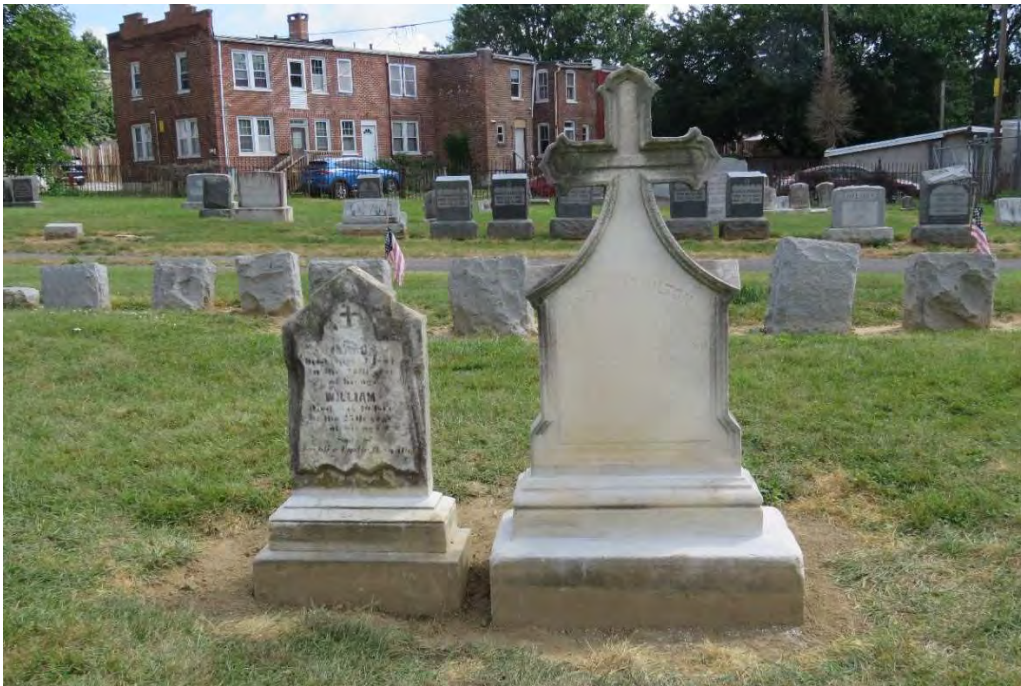
Front

Back

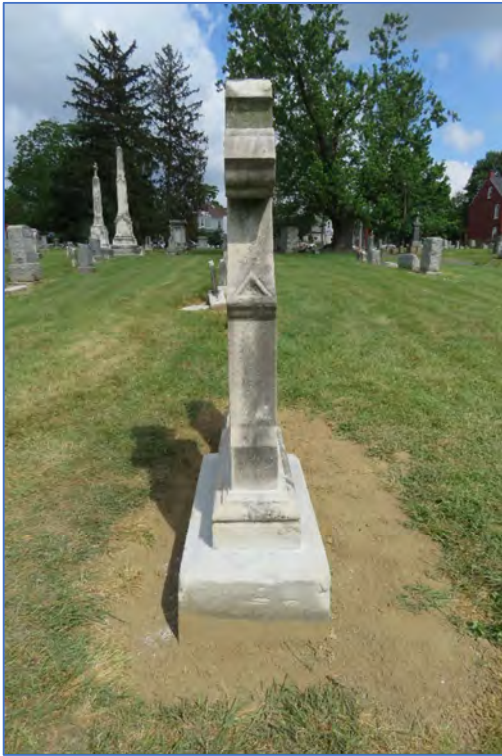
Right Side

Left Side

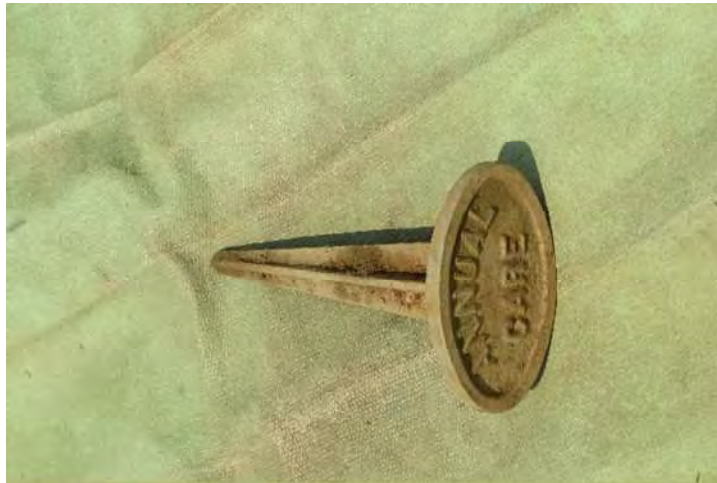
As Found Ground Marker
