Saint Mary's Cemetery

Lot Report

Lydia Hamilton Smith Plot

Section 2, Row 6, Gravestones 17 & 18

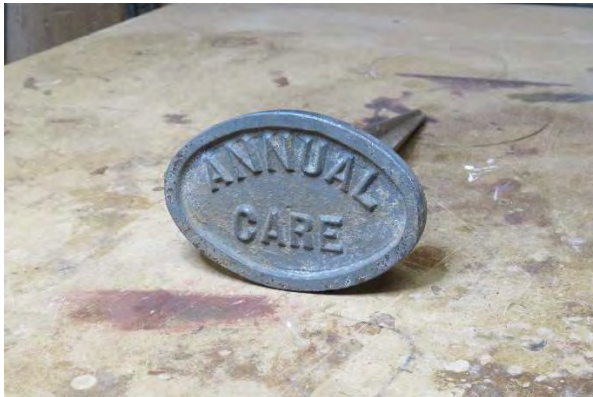
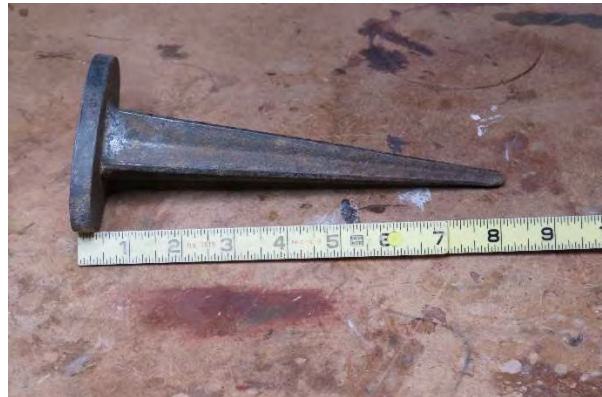
Ground Marker After Rust Removed

As mentioned, during the excavation of Lydia Hamilton Smith's gravestone base, a metal ground marker stating "ANNUAL CARE" was discovered in the ground at the back center of the base. The ground marker was cleaned with water and the rust removed with five applications of Rust-Oleum Rust Dissolver Jelly. The marker was then painted with Krylon Fusion Gloss Black spray paint. The marker was then placed in the ground at the back center of Lydia Hamilton Smith's gravestone base where it was found. Below are photos of this process.

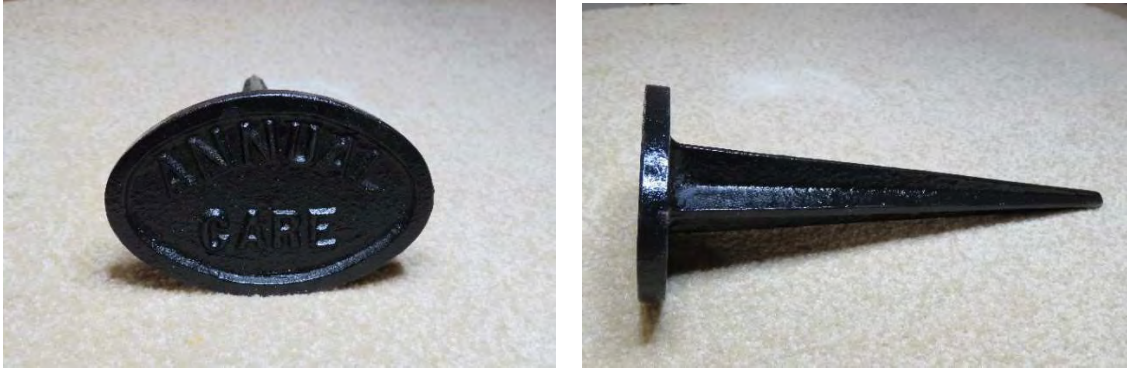
Ground Marker Painted

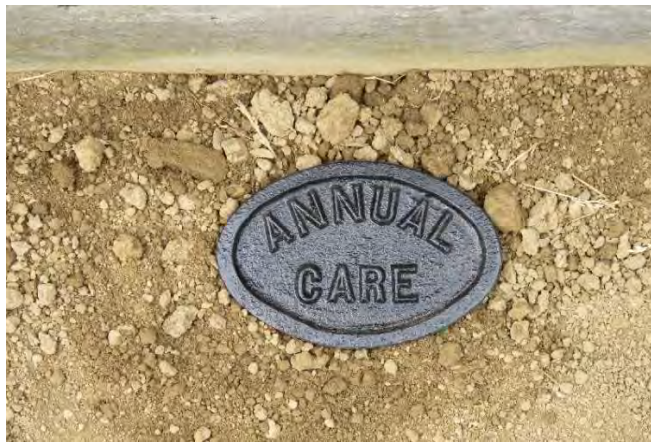
Ground Marker Replaced

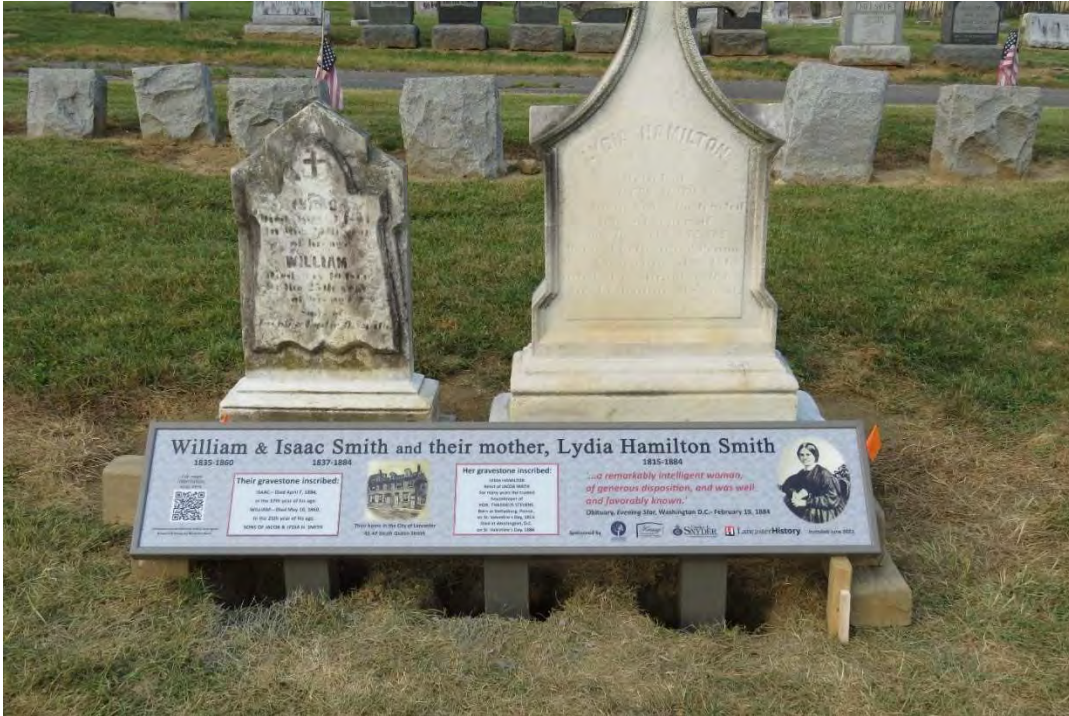
Sign Fitted in to Holes

- The sign was assembled and the three legs held in place to mark their locations in the soil.
- Three holes were dug to approximately 30" depth.
- A 4" gravel base of chipped mini-marble was placed in each hole.
- An 8" diameter Quikrete concrete form was placed in each hole. Each form was ~1.3' long.
- The sign assembly was inserted into the forms, centered to the gravestones, leveled and staked in place. The sign was placed as follows.
 - Top of the sign was 11" from the base of Lydia's gravestone.
 - Bottom of the center of the sign was 5" from ground level.
 - Top of the center of the sign was 15" from the ground.
- One 80 lb. bag of Quikrete High Strength Concrete was mixed and inserted into each form. The excess was used to support the form in the hole.
- Covered unit with a tarp.
- After 24 hours, the stakes were removed and holes filled with removed soil.

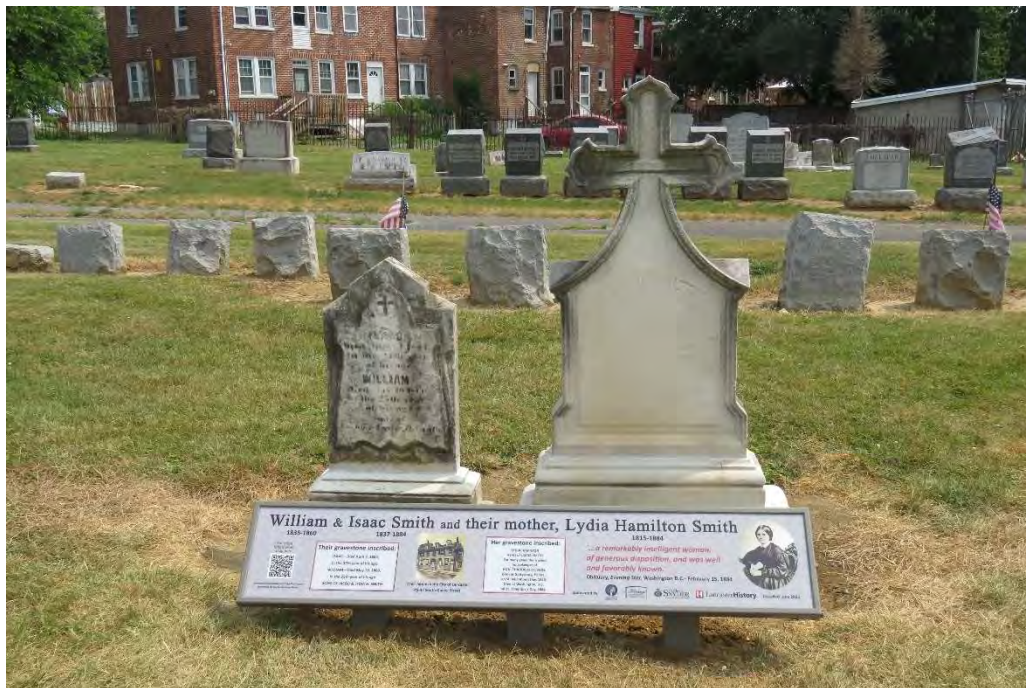
As Left Photo
